WATER and RELATED LAND RESOURCES

EL RIO EN MEDIO SUB-BASIN

UPPER RIO GRANDE BASIN

PRELIMINARY EARLY ACTION OPPORTUNITIES

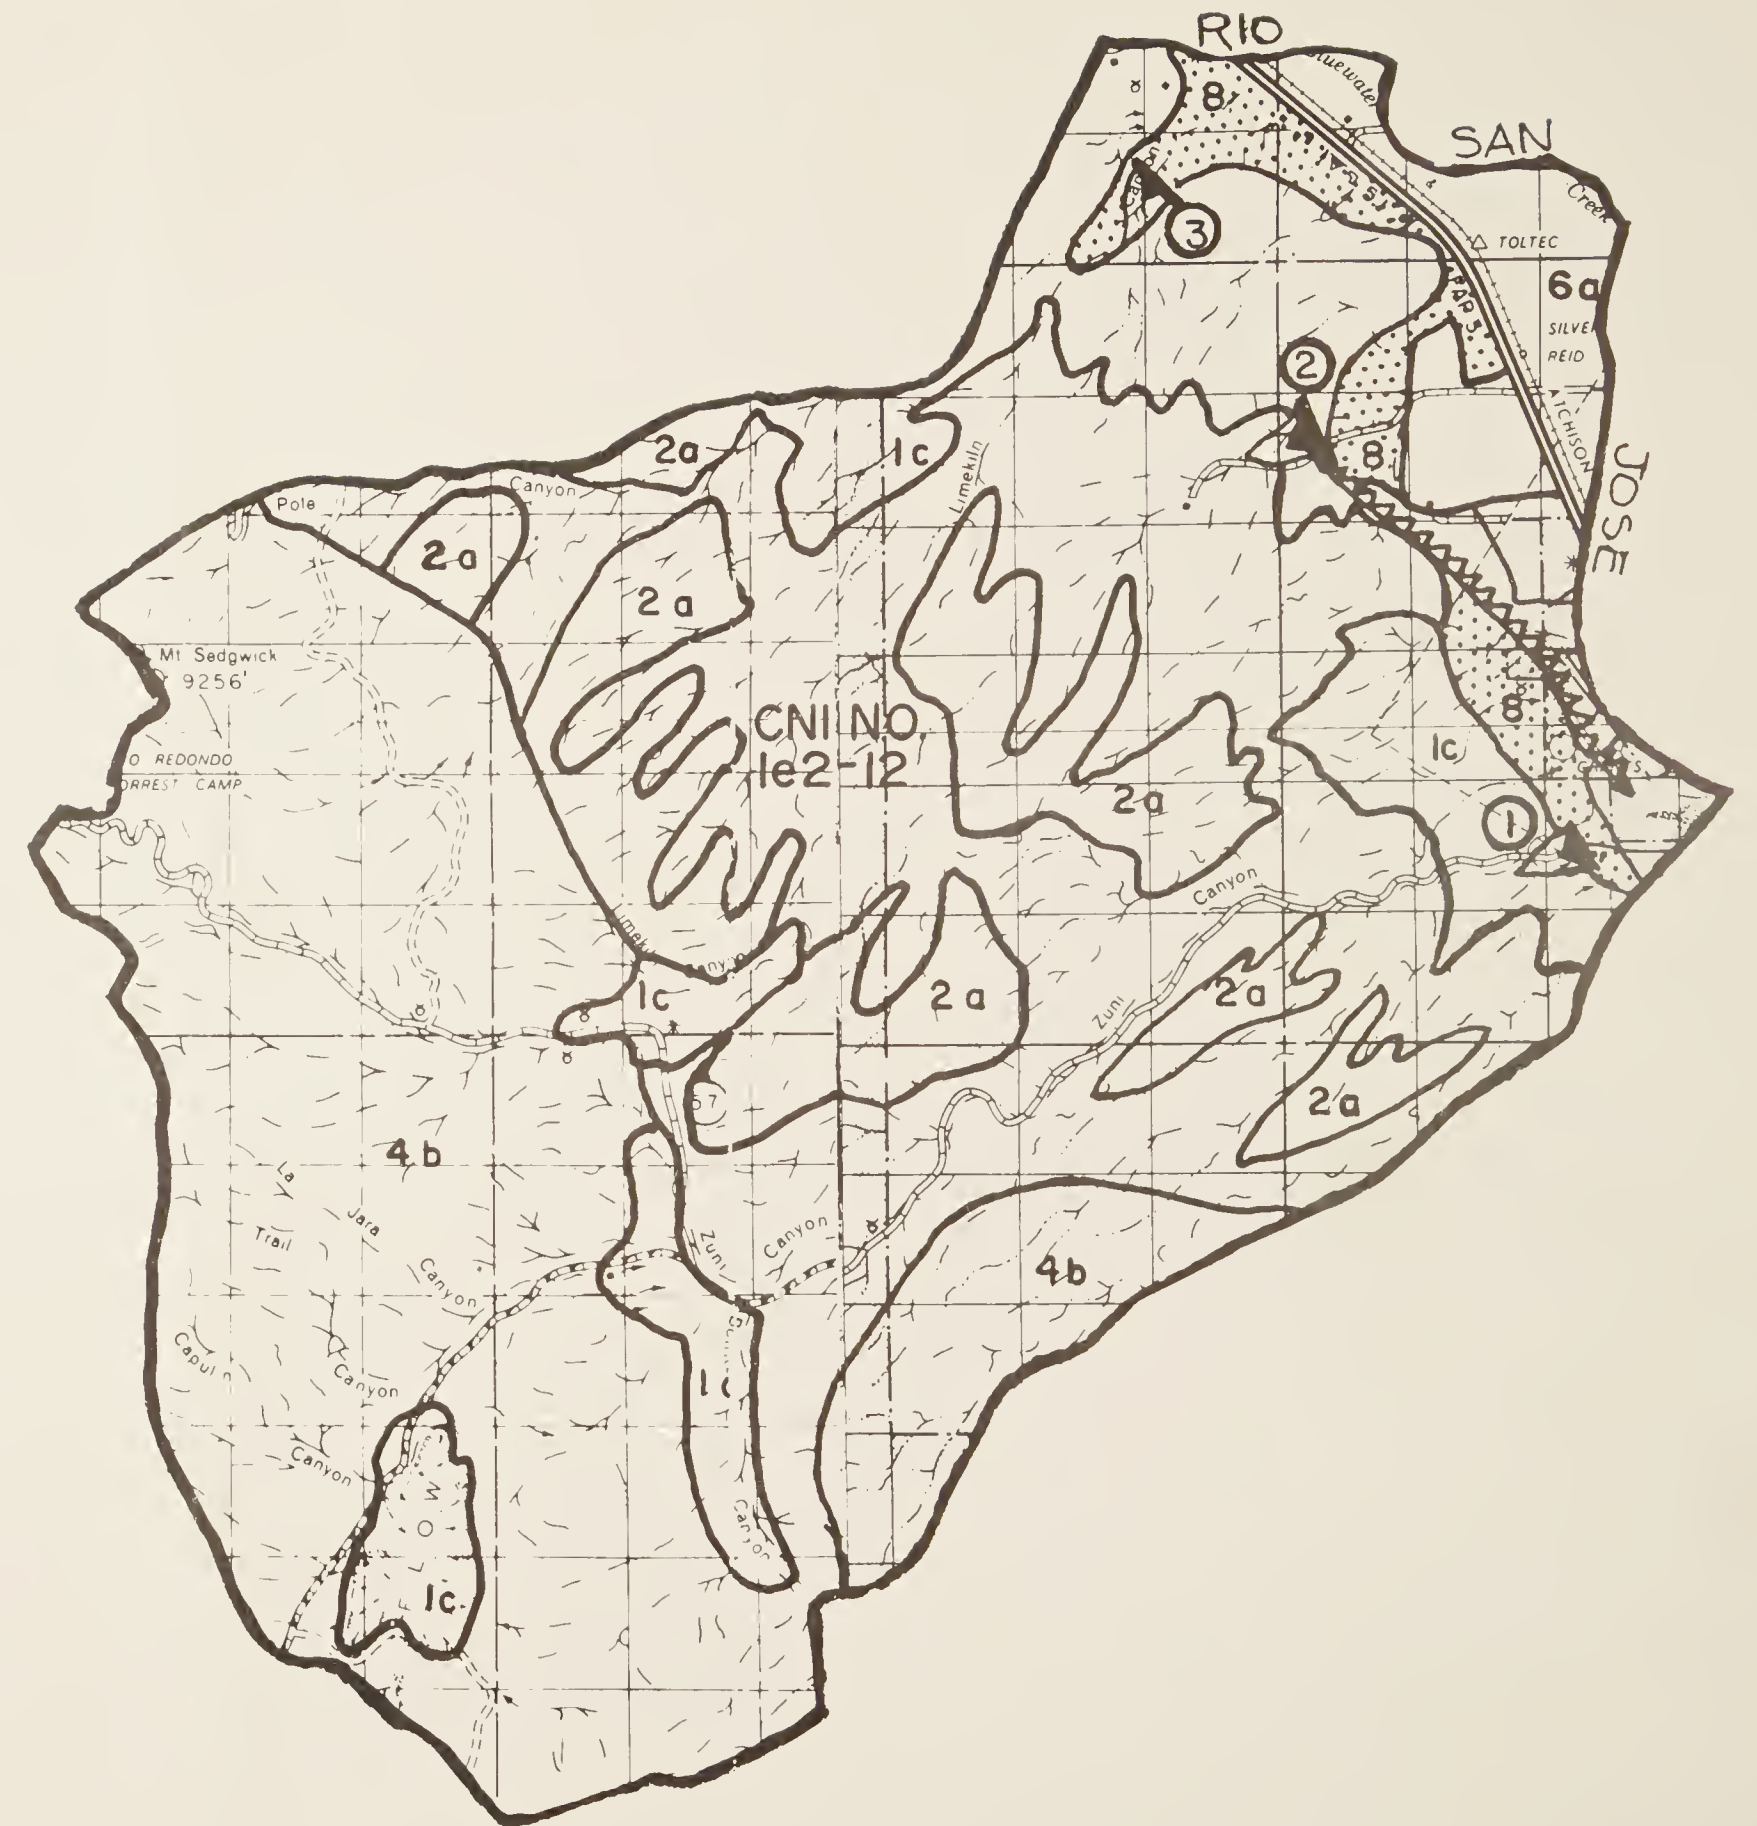
STRUCTURE LOCATION
AND
LAND TREATMENT MAP
POLE-ZUNI CANYON WATERSHED
UPPER RIO GRANDE BASIN

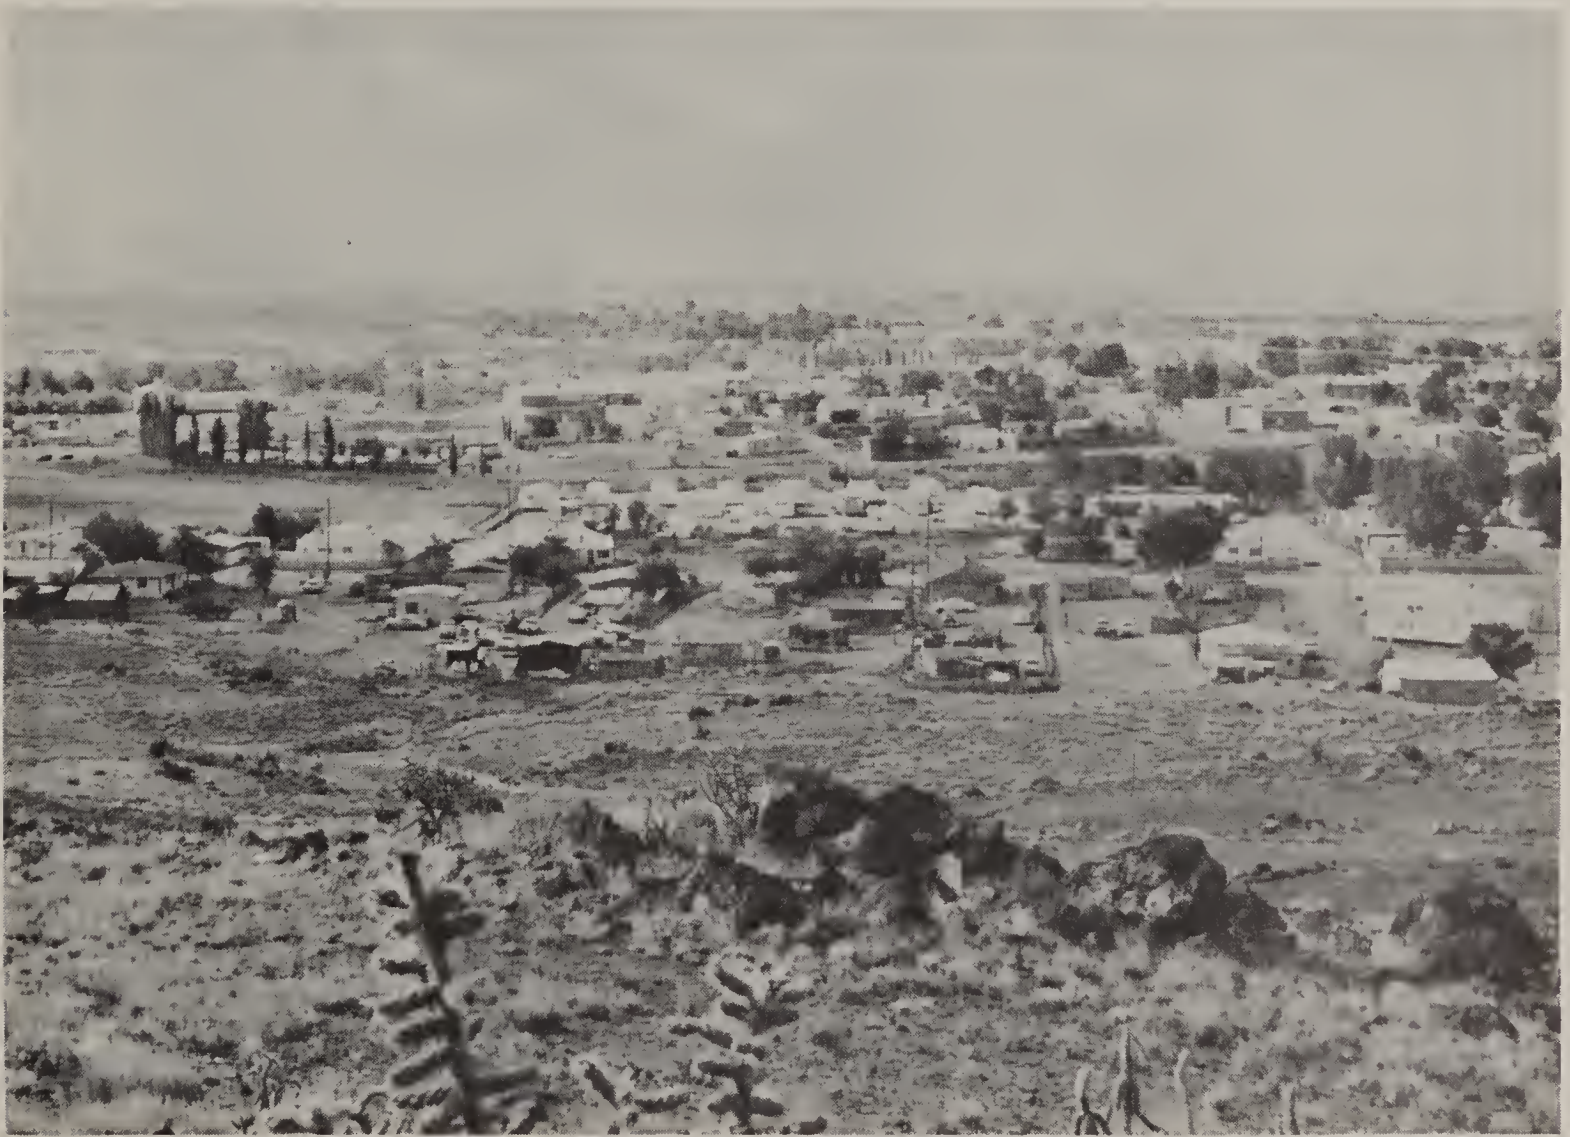
Looking east over Grants. Rio San Jose enters at right center. Flooding occurs in the area shown across the center of the photo. SCS PHOTO 12-P993-16

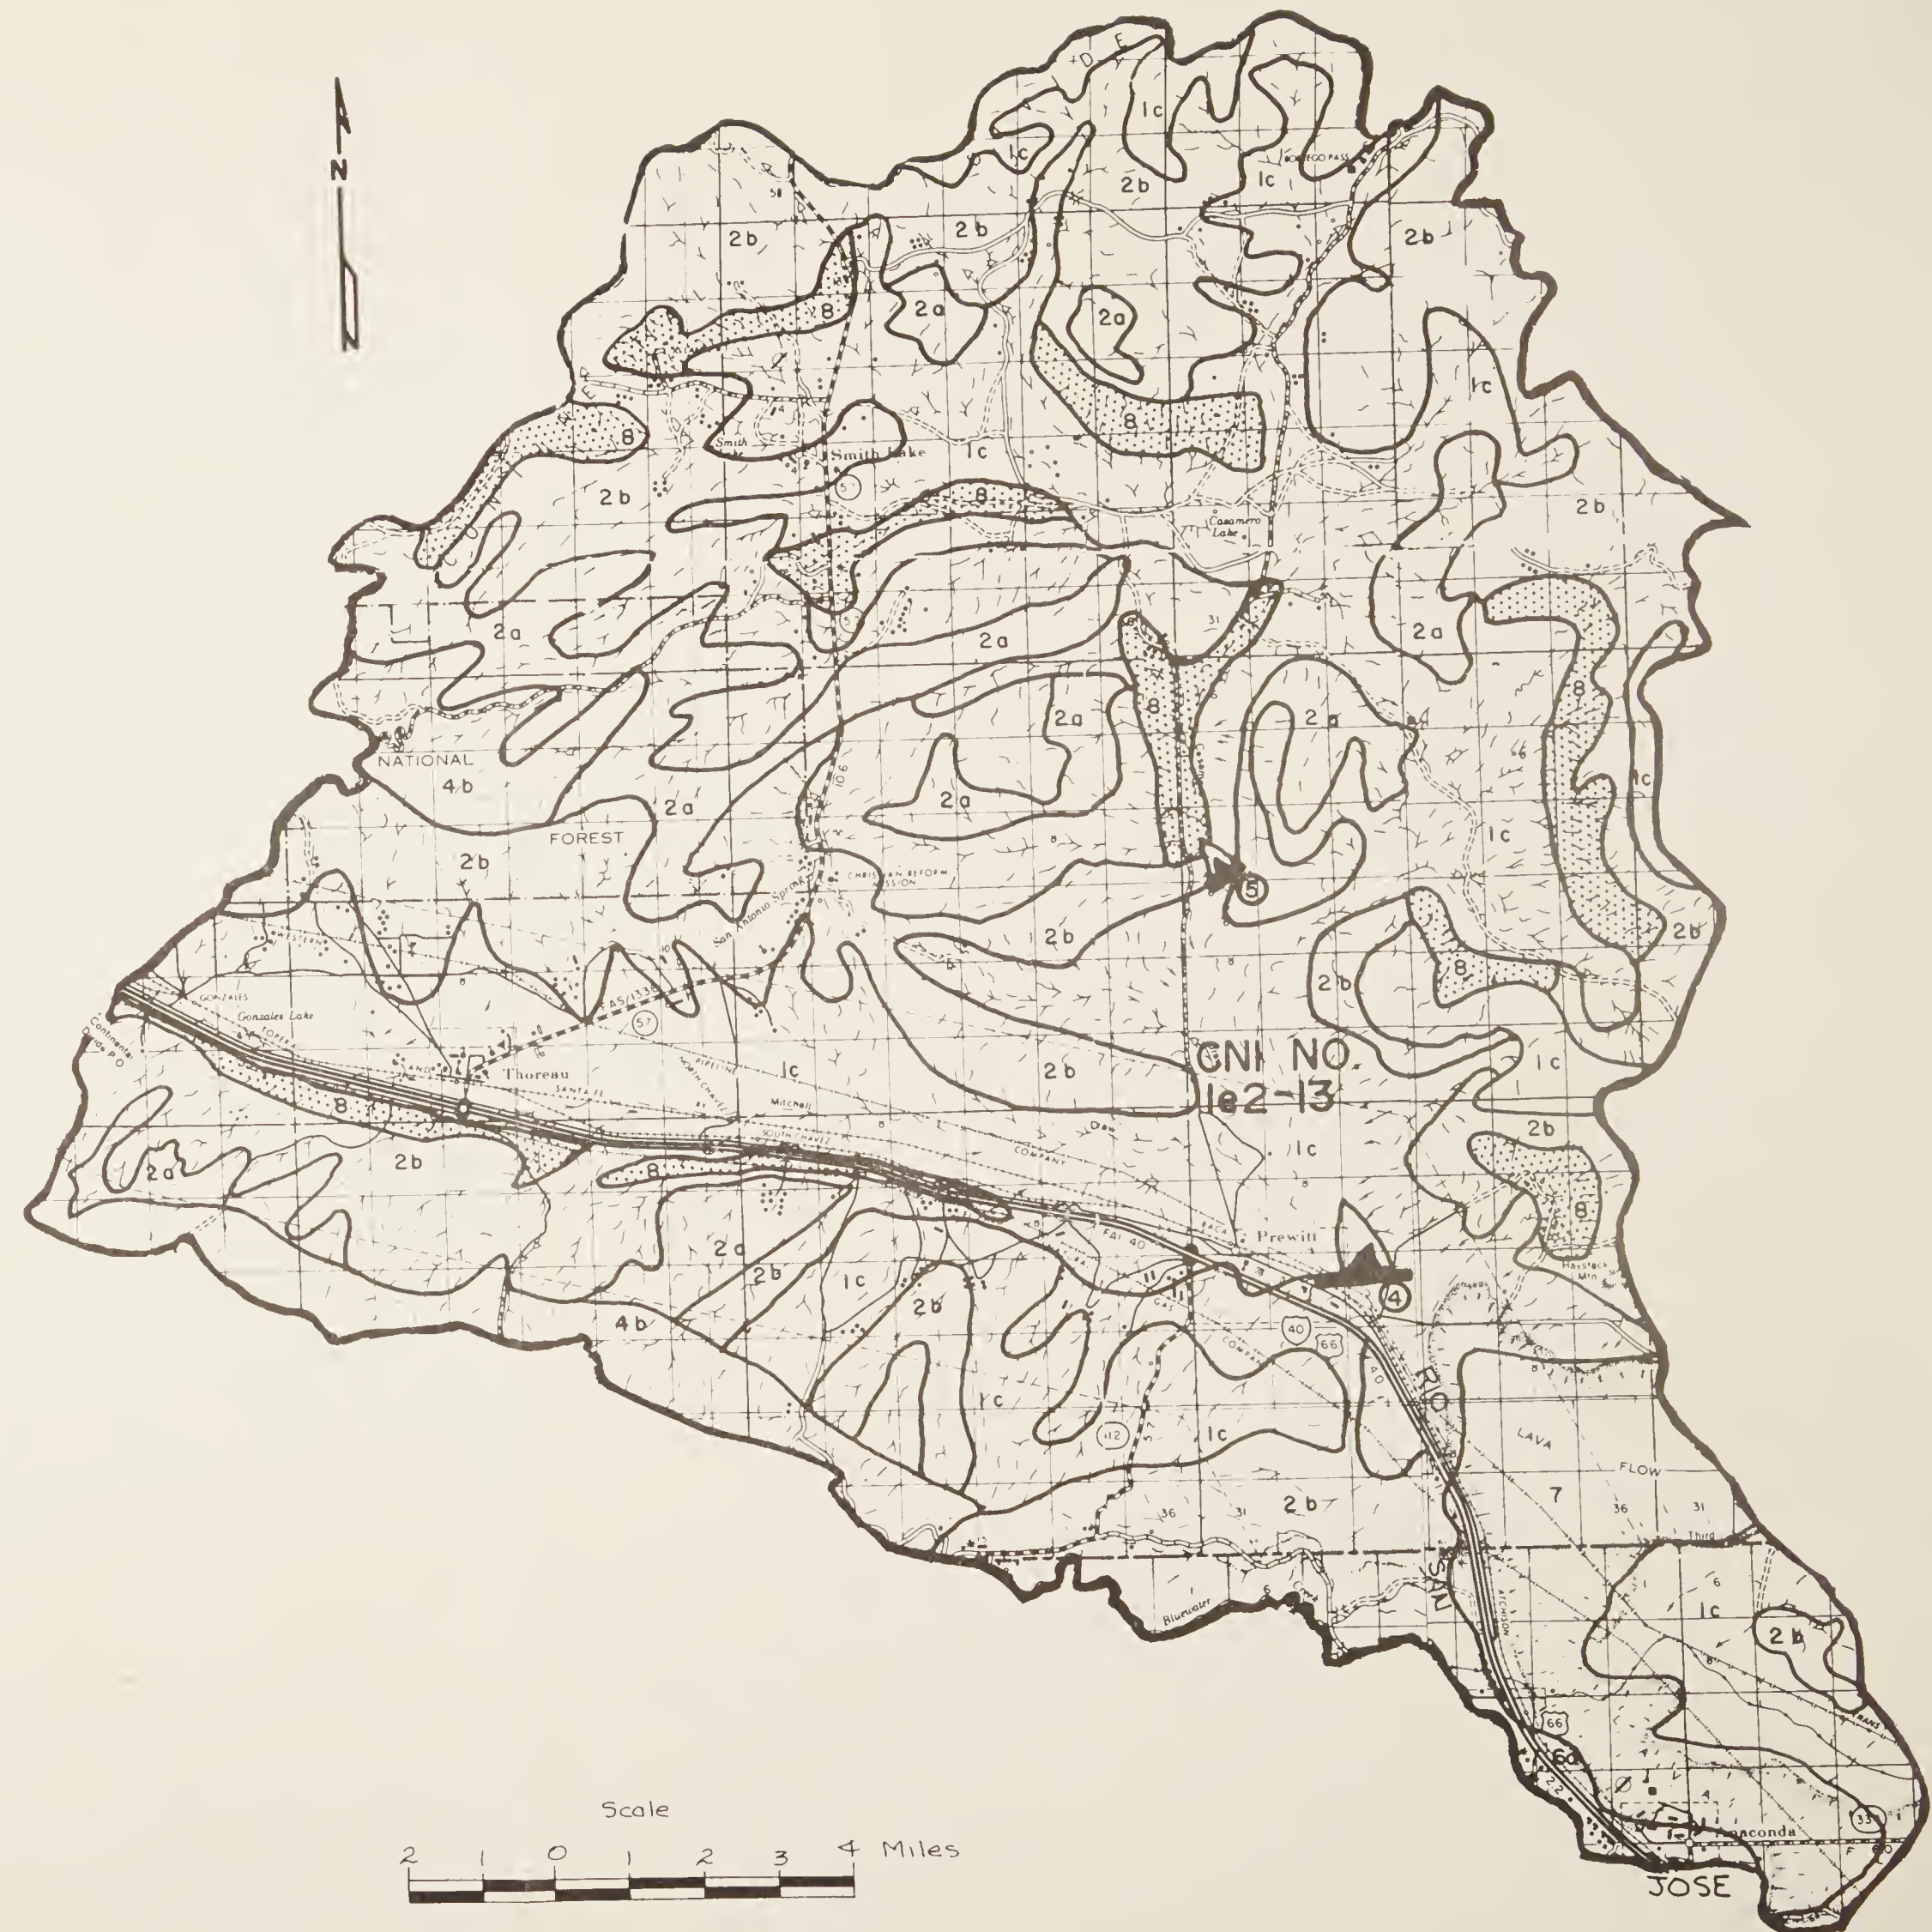
STRUCTURE LOCATION
LAND TREATMENT MAP
RIO SAN JOSE WATERSHED
UPPER RIO GRANDE BASIN

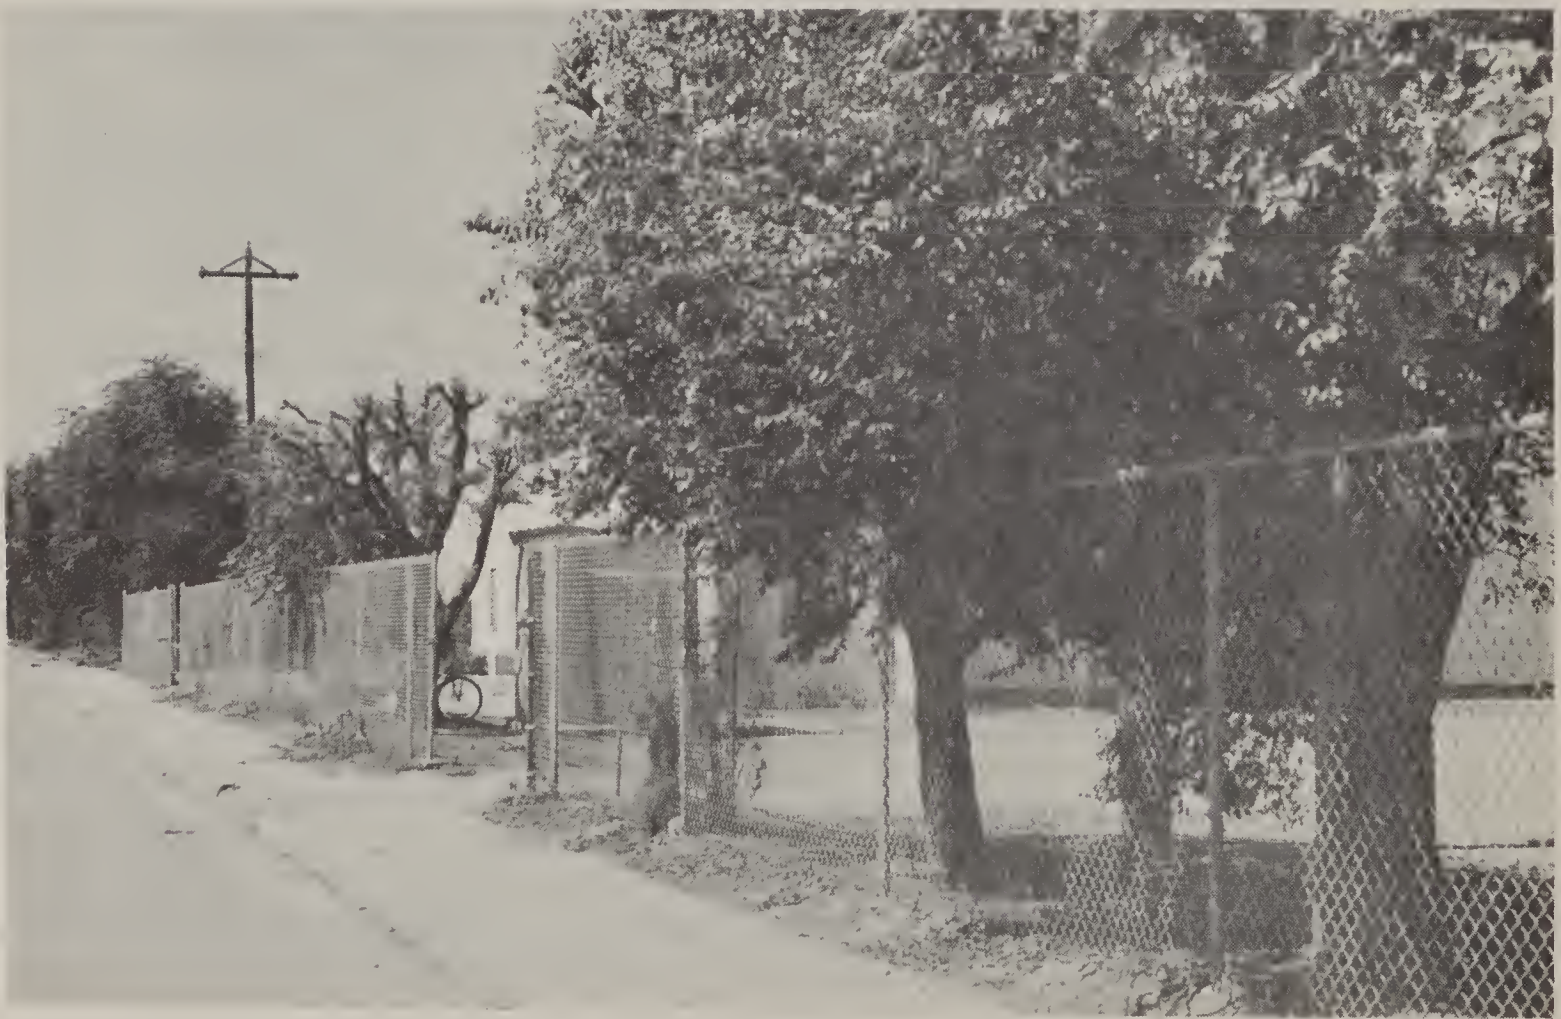
Urban damage area. Fence still retains trash from last year's high water

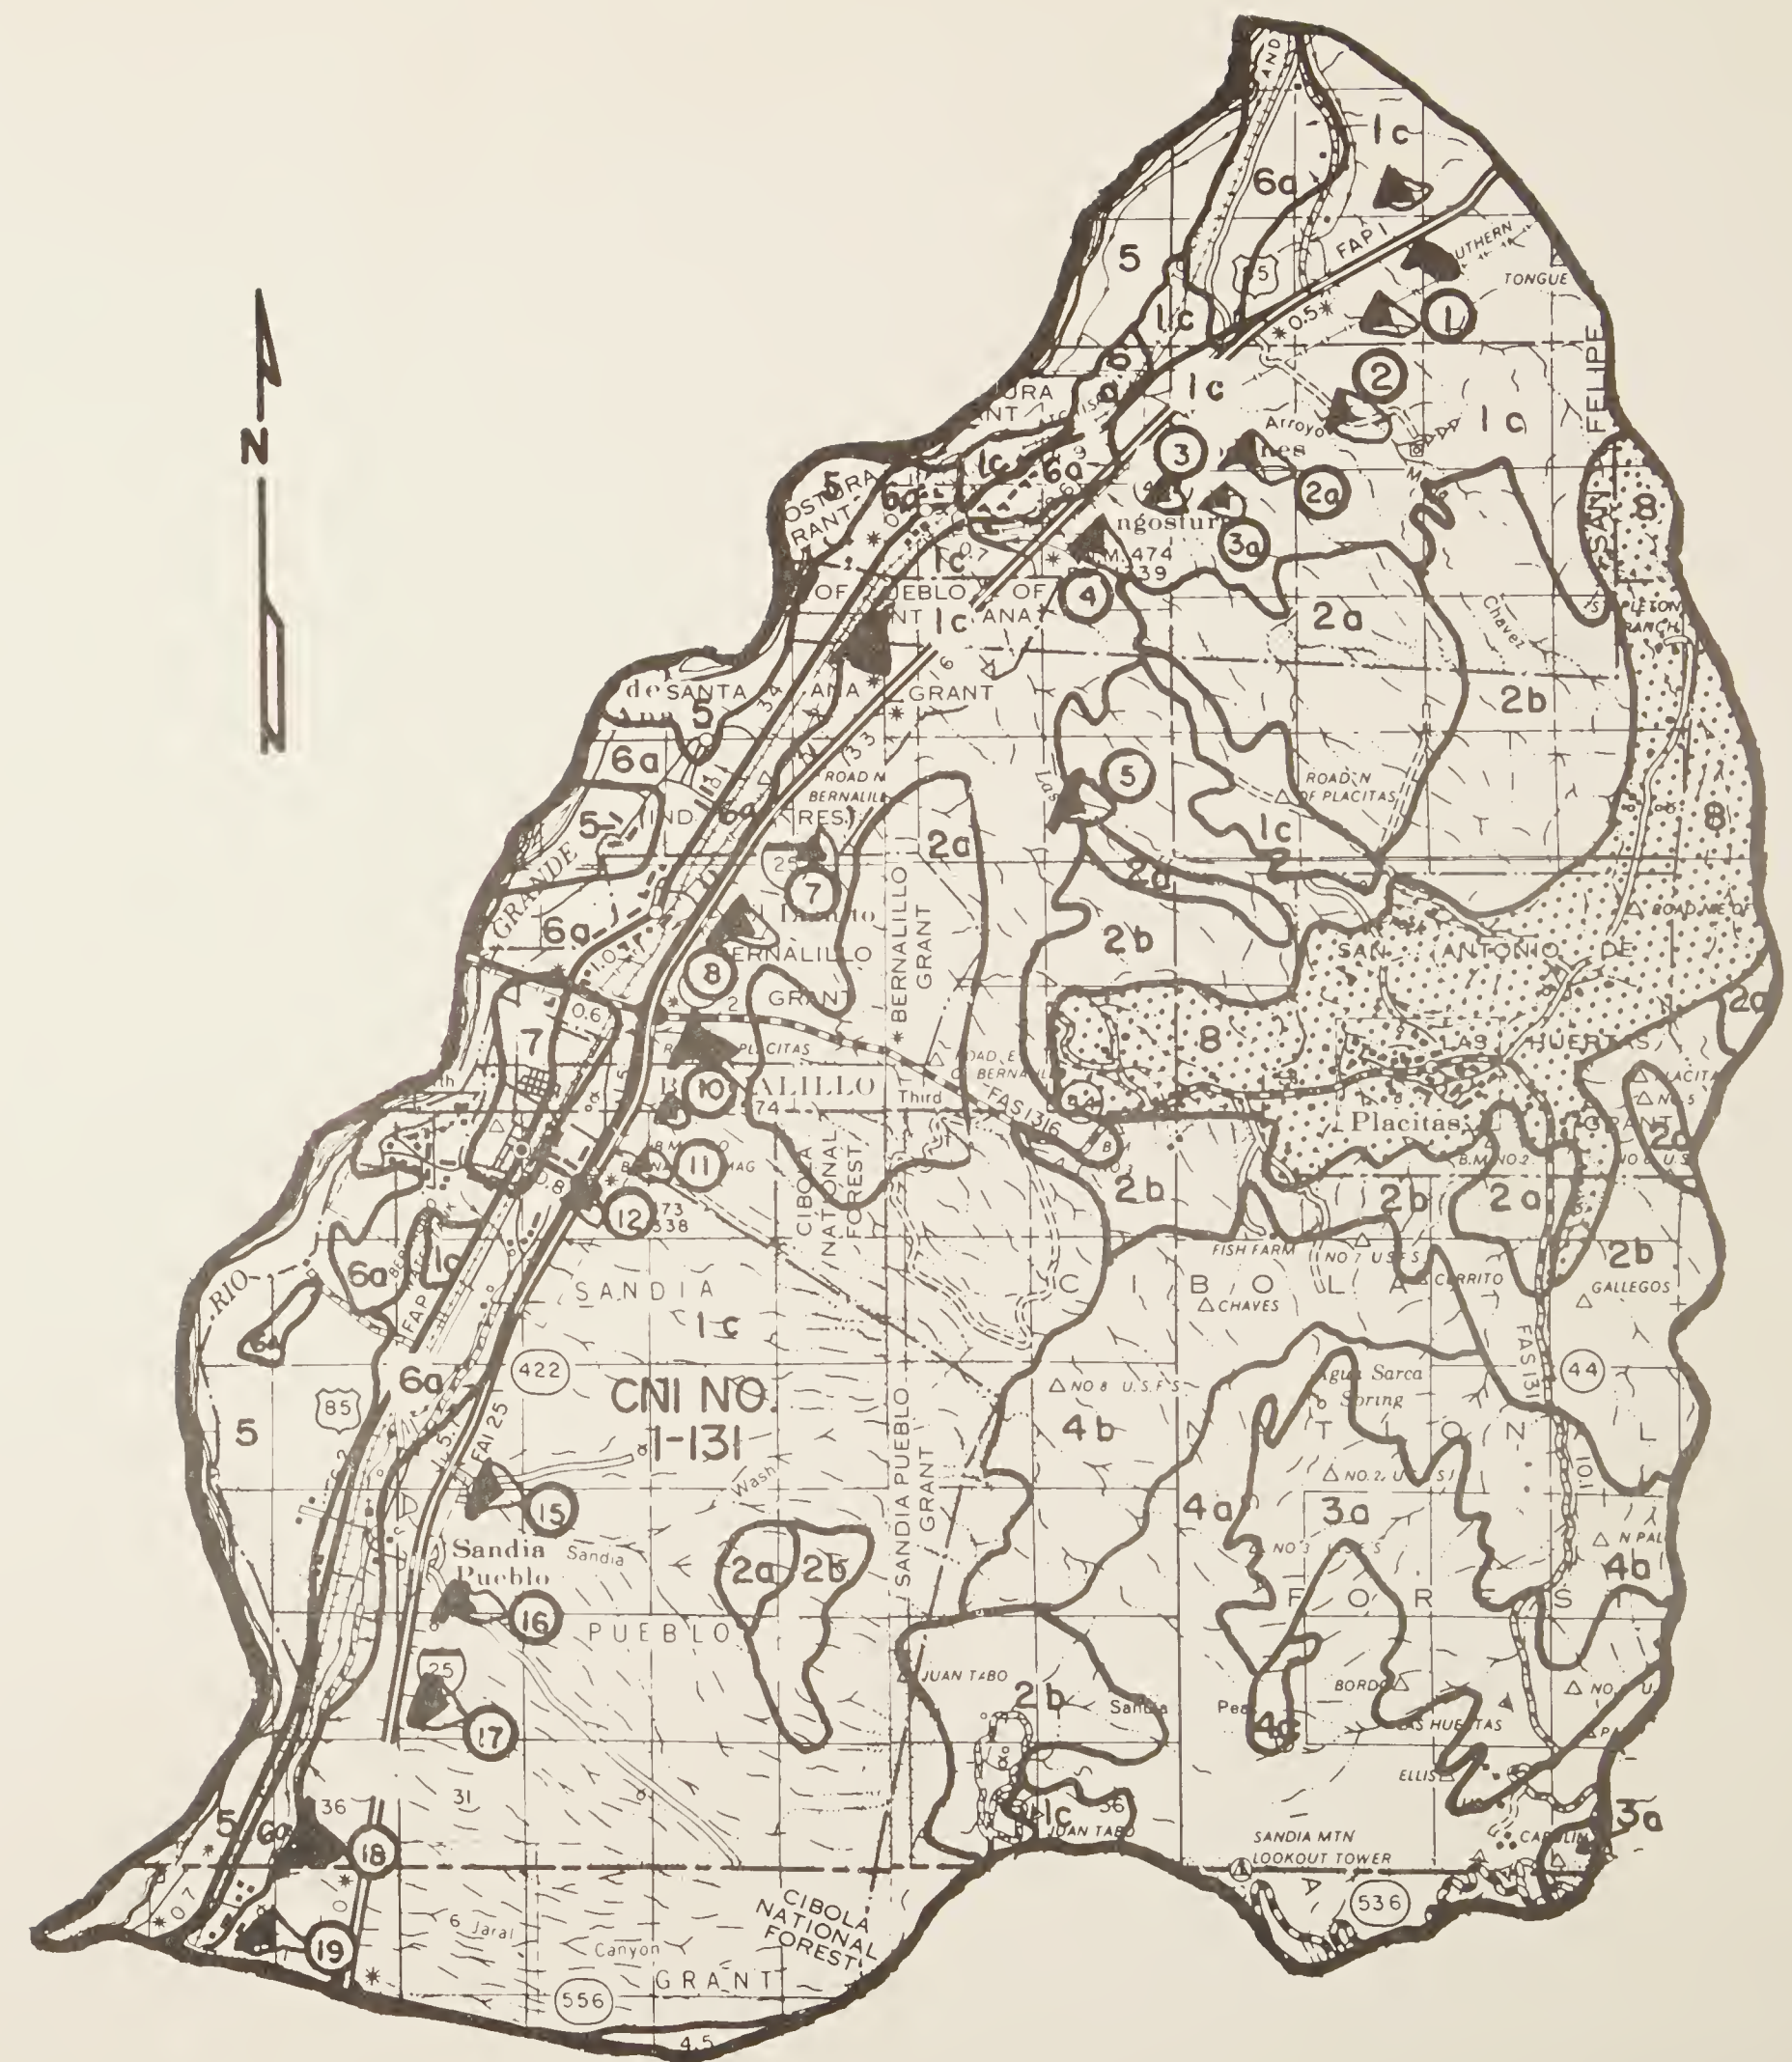
STRUCTURE LOCATION
AND
LAND TREATMENT MAP
SANDIAS WATERSHED
UPPER RIO GRANDE BASIN

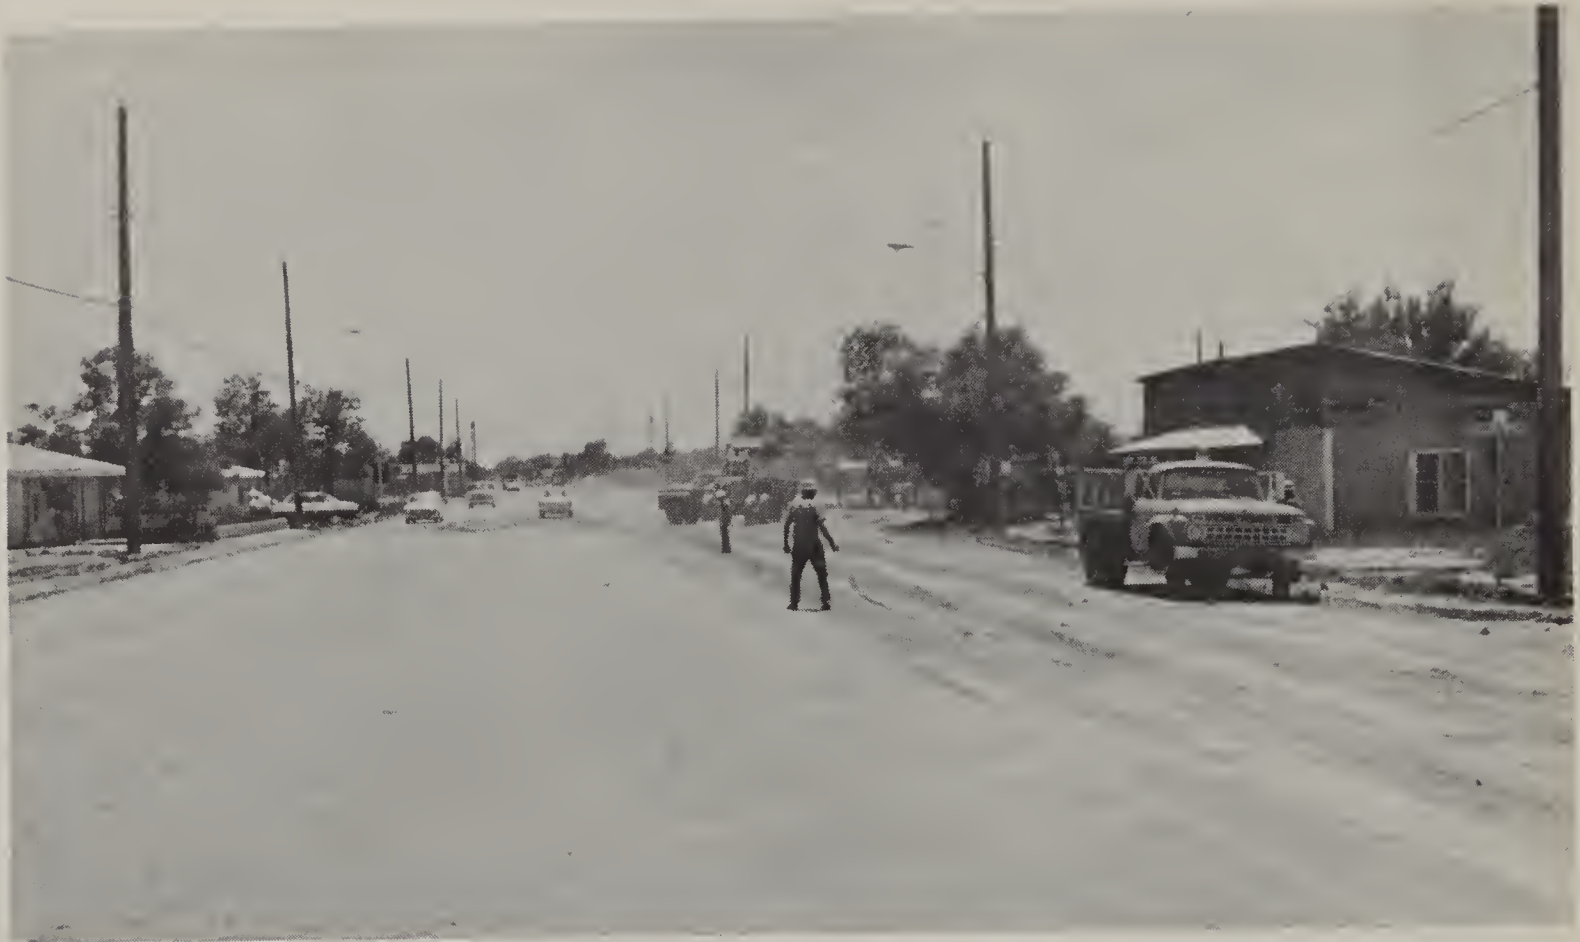
Removing sediment from Main Street in Belen, New Mexico, June 1969

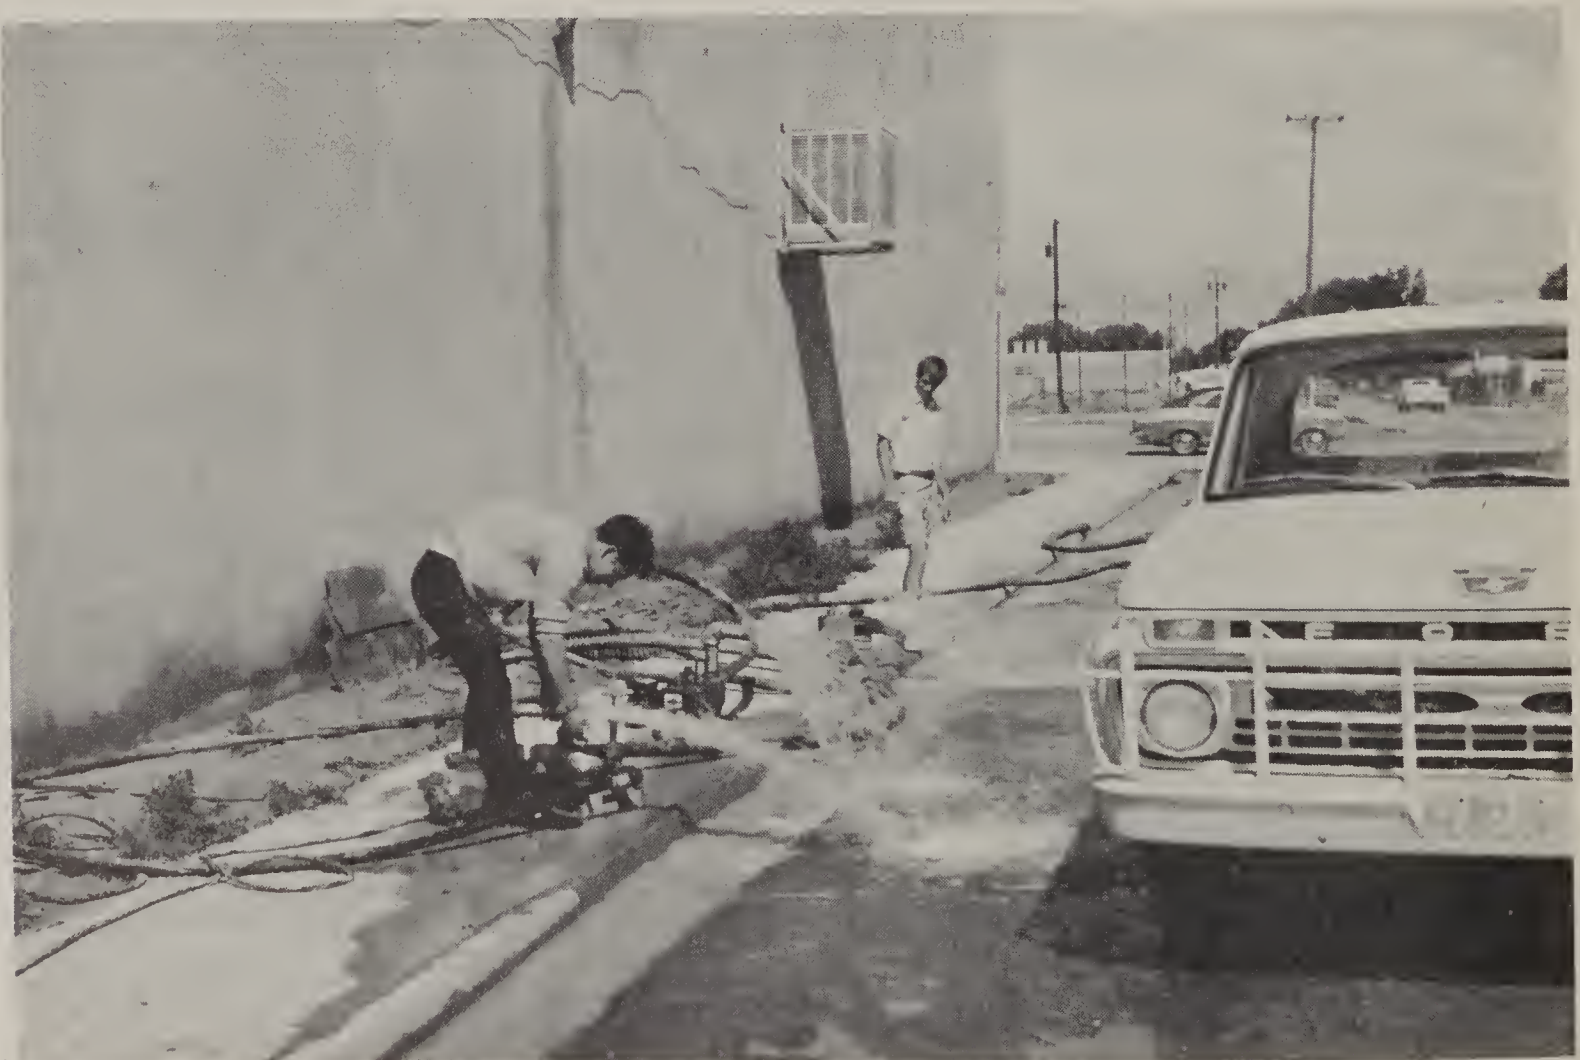
Pumping floodwater from basement in downtown Belen, New Mexico, June 1969

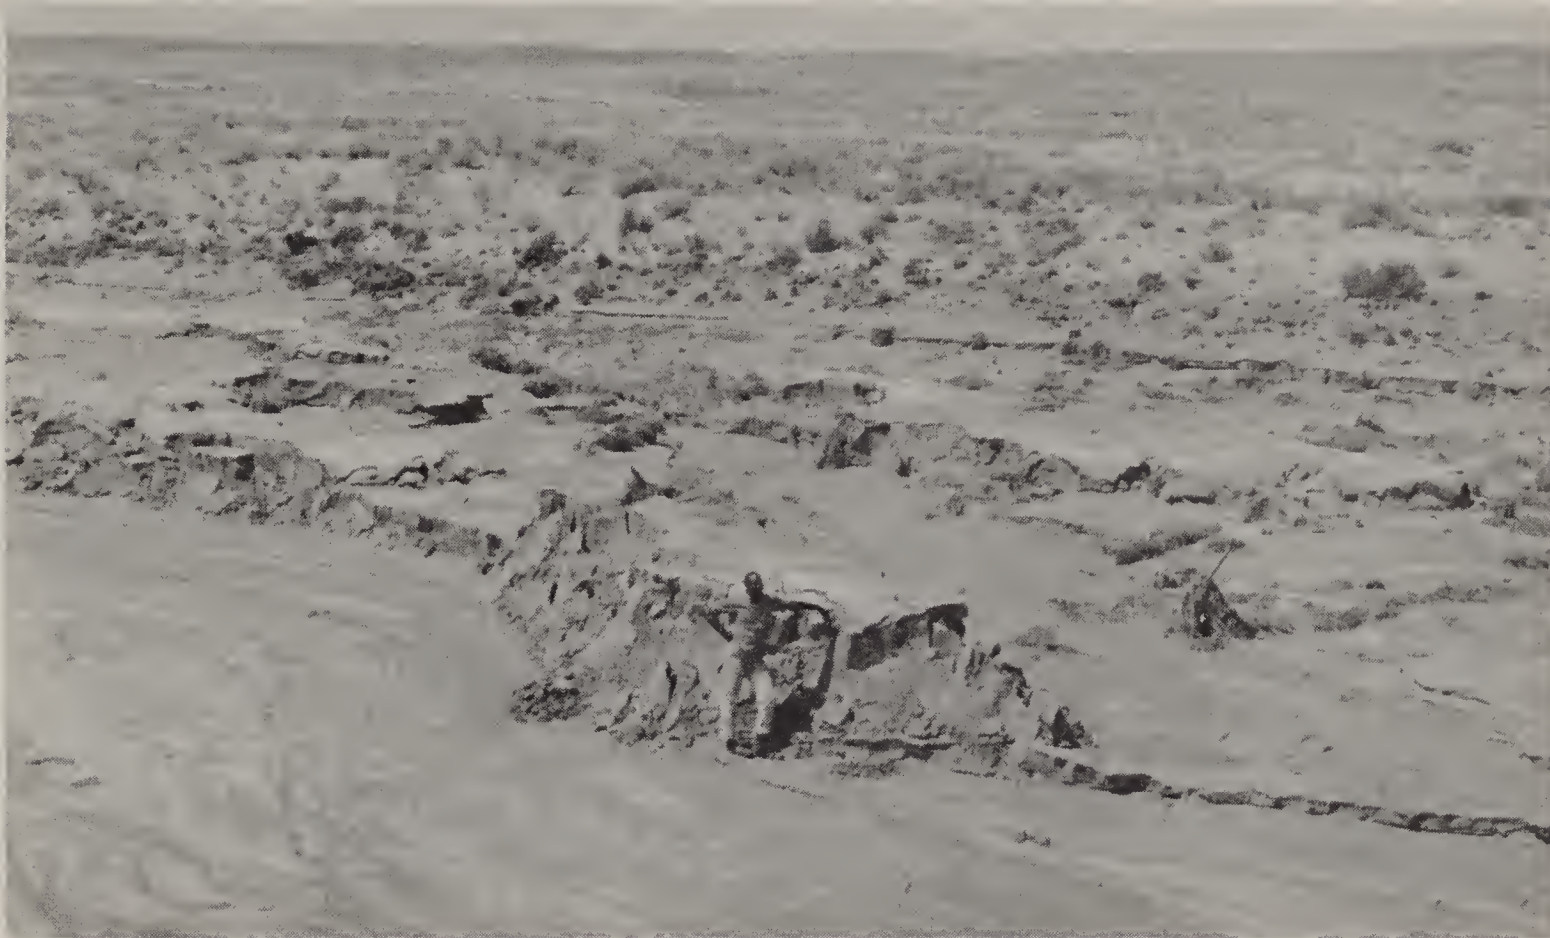
Channel erosion on the Arroyo de Los Montoyas above the Corrales area from 1960 flood.
